# Keeping up appearances

When the Billingtons bought a run-down, aging park home they saw through its battered exterior and in under two weeks their home had undergone a total transformation

**EXTREME MAKEOVER: HOW IT WAS DONE**

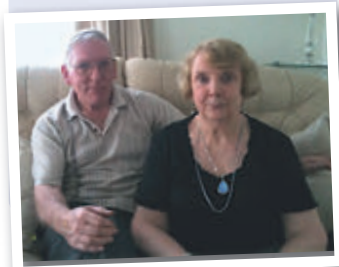
**Right: This tired and dated property was given a new lease of life by Rapide**

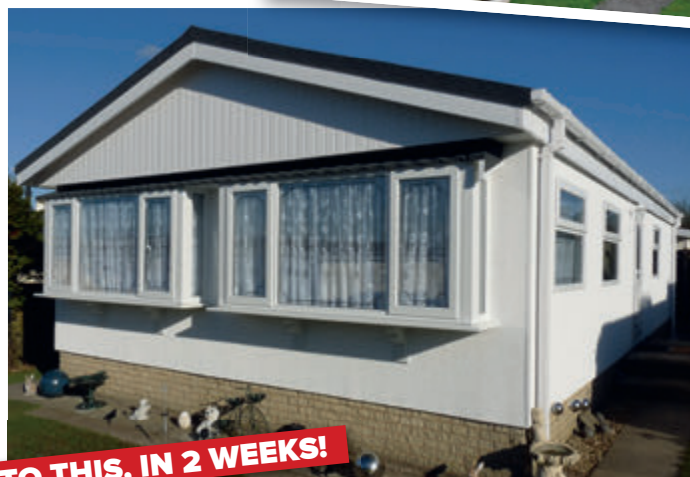
**TO THIS, IN 2 WEEKS!**

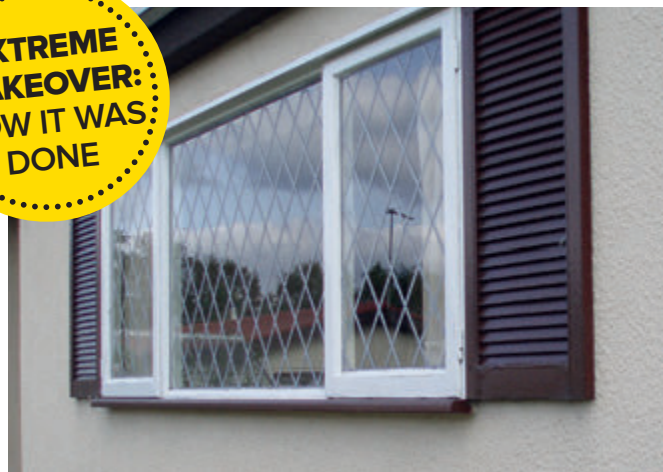
▲ **Before:** All the original single glazed wooden windows were showing signs of decay or rot. The doors had been replaced with uPVC but these had been poorly fitted and were made for a bricks and mortar home. They needed to be replaced with uPVC double glazed units which would be fabricated with an odd leg outer frame, specifically for park home use.

The couple had seven windows replaced in total. The old ones were water damaged and in dire need of repair so the couple opted to start again. They decided to fit leaded windows in a similar style to their previous property.

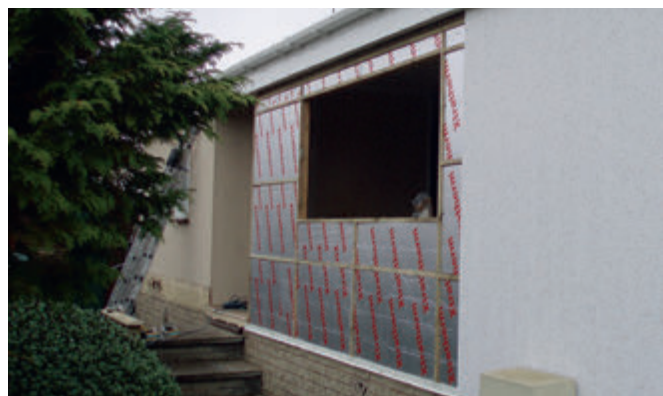
▲ **During:** The windows were replaced with uPVC double glazed units to enhance the home and give more windowsill space in the lounge. The Billingtons replaced old fashioned splay bays with box bays, installed with GRP gallow brackets to the underside and a feature tiled roof canopy which would continue across the home and match the new tiled roof.

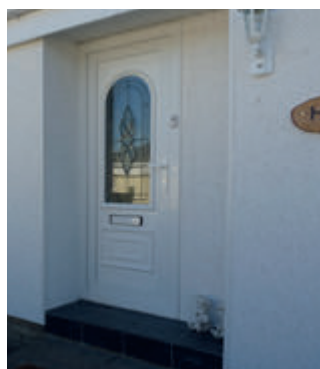
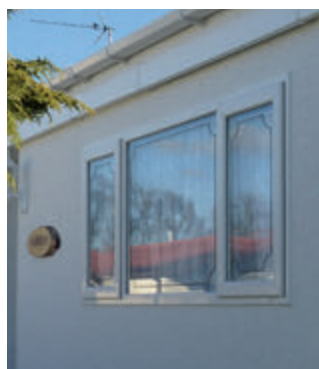
▲ **After:** The front hall door had a continual decorative uPVC panel with stained cut glass. The kitchen door however was a more functional mid-rail door with obscure glass in the top and a Georgian panel below. The Billingtons decided to enhance the glass in the windows using border lead, similar to their previous bricks and mortar property.

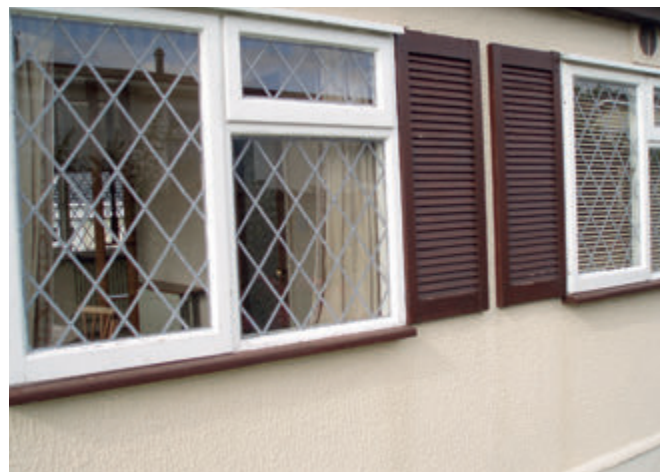
▲ **Before:** The original plywood texture coated outer walls were showing serious signs of decay, some of the boards had rotted and the drip bar had perished. The outer wall boards needed to be removed and the original wall structure would need to be checked over. After explaining and discussing the various wall renovation options available, the Billingtons decided to opt for the total non-maintenance, energy-efficient, thermally-enhanced wall renovation.

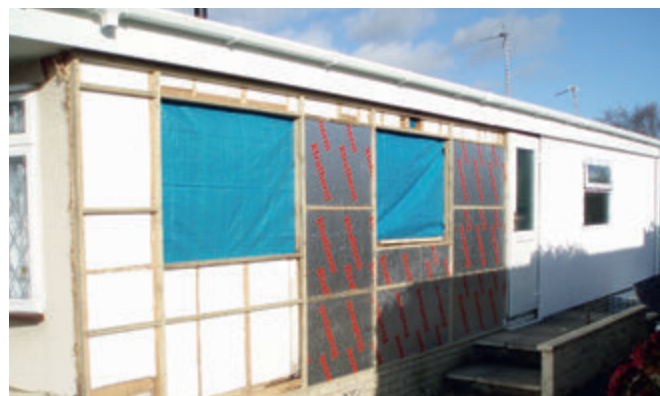
▲ **During:** The existing outer wall boards had to be removed and rotten timbers replaced from the existing wall structure. The wall thickness was doubled by screwing tanalised timbers onto the structure. Thermax PIR insulation board was fitted inside the new wall structure on top of the existing quilt insulation. Vinytherm uPVC cladding board was installed.

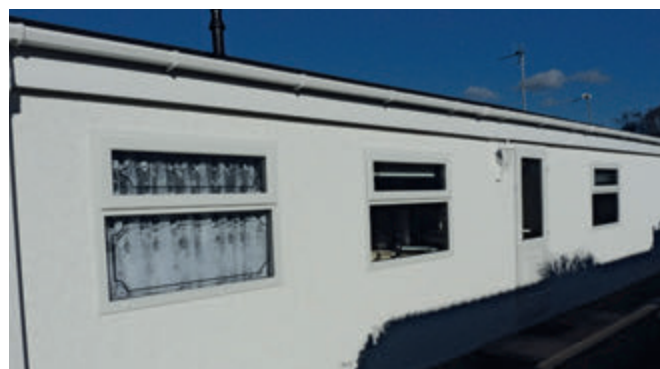
▲ **After:** Vinytherm has a unique integral cavity which creates a continuous air circulation between the additional insulation/structure and the outer wall surface. This results in a maintenance-free outer wall finish and an enhanced thermally efficient wall structure keeping the home free from condensation and rot while being warmer in the winter and cooler in the summer.

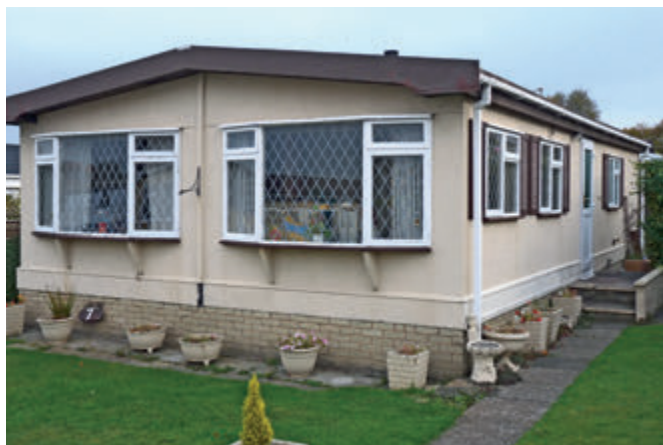
The roof was leaking and with winter fast approaching, needed to be fixed as soon as possible. This meant Rapide prioritised work on the roof first, especially as the home had some problems with damp, due to the previous owner blocking the air vents.

▲ **Before:** The roof covering was still the original Hyplon blanket and had perished over the years. Water ingress was evident so Rapide suggested to replace it with a new granulated lightweight pitched tiled roofing system. There was also evidence of rotting fascia/barge boards and the guttering was on its way out and leaking.

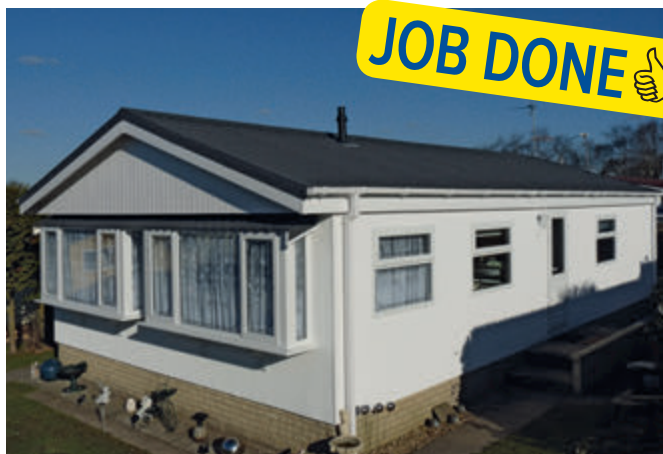
▲ **After:** New, maintenance free, uPVC fascia/barge boards with guttering were installed. This allowed Rapide to increase the pitch of the roof pre-formed gable ends with white uPVC open 'V' board cladding and trusses with lateral/diagonal bracing where screw fixed into the original roof. Klobber reinforced underlay and tanalised battens were then secured to the new roof carcass. Finally the granular lightweight tiles and trims were fitted.
